## Letter to the Editor

**Severe Acute Respiratory Syndrome Coronavirus 2 (SARS-CoV-2) Contamination of High-touch Surfaces in Field Settings\***

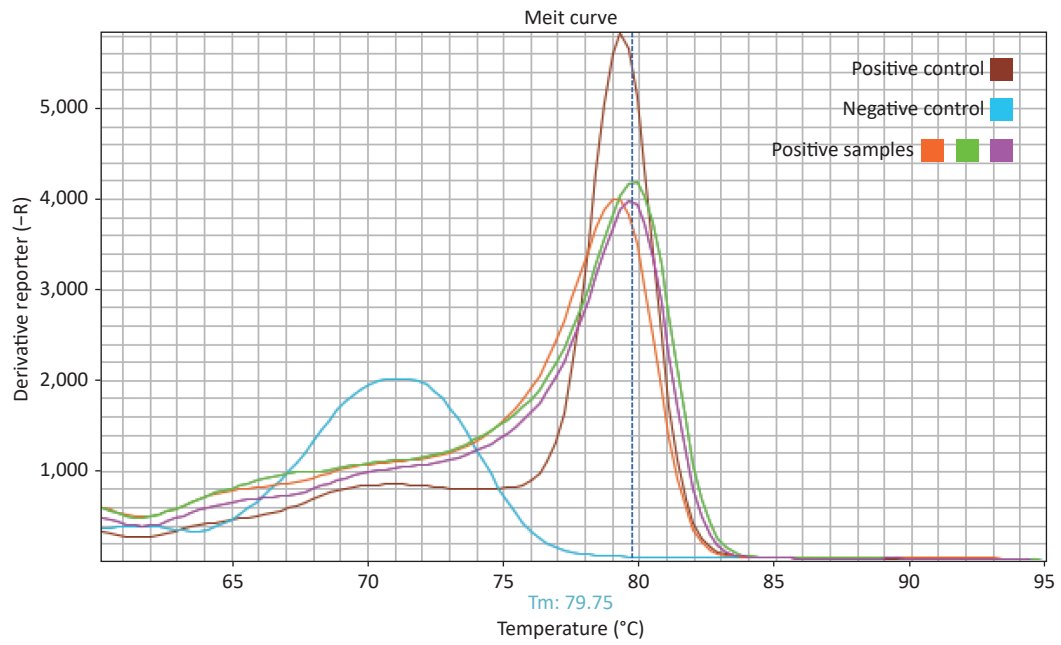
**Supplementary Figure S1.** Melt curve analysis of positive samples (RdRp gene).
